RESERVOIRS  
FOR IRRIGATION, WATER-POWER  
AND  
DOMESTIC WATER-SUPPLY

WITH AN ACCOUNT OF VARIOUS TYPES OF DAMS AND THE  
METHODS, PLANS AND COST OF THEIR CONSTRUCTION

JAMES DIX SCHUYLER

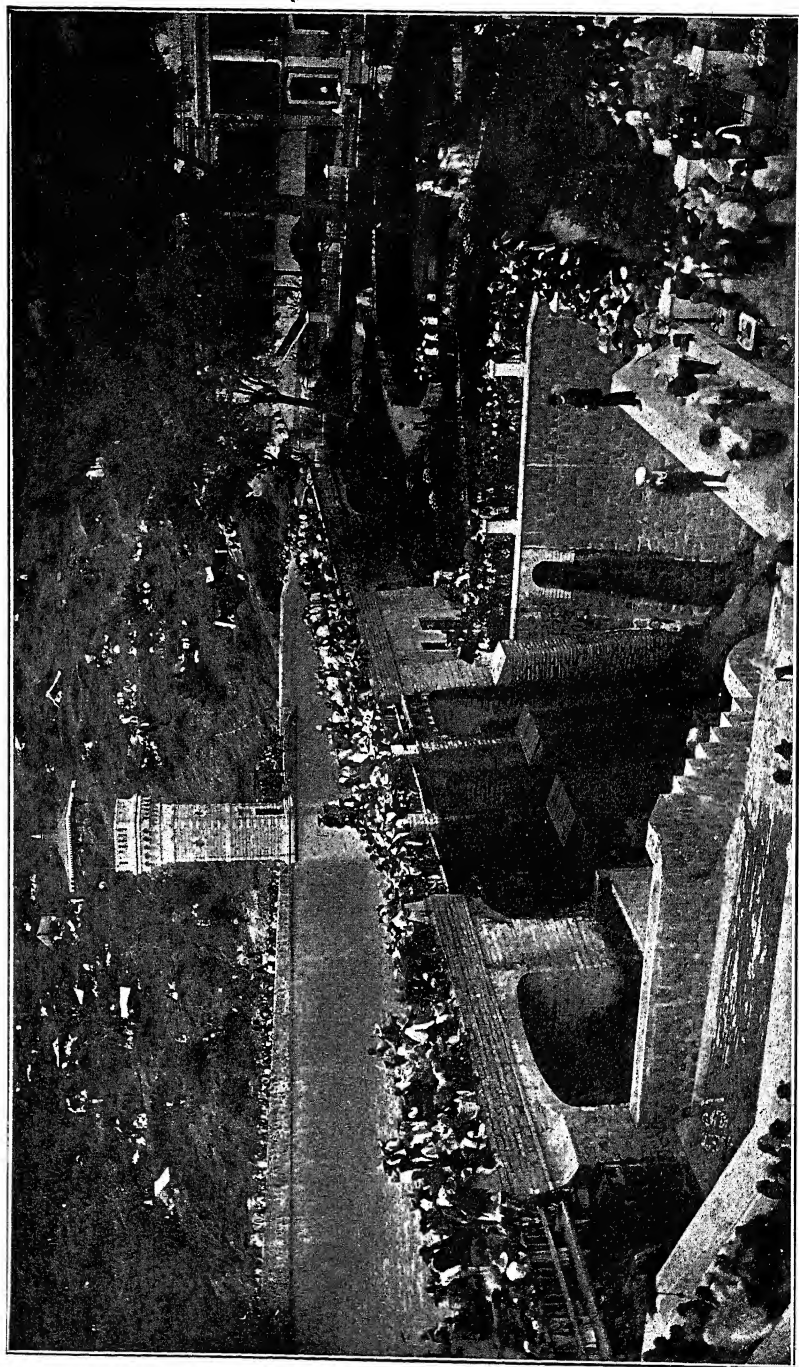
FIG. 255.—LOWER DAM, OR "PRESA DE LA OLLA," GUANAJUATO, MEXICO. VIEW TAKEN DURING THE FEAST DAY WHEN THE GATES ARE RAISED AND THE RESERVOIR EMPTIED.

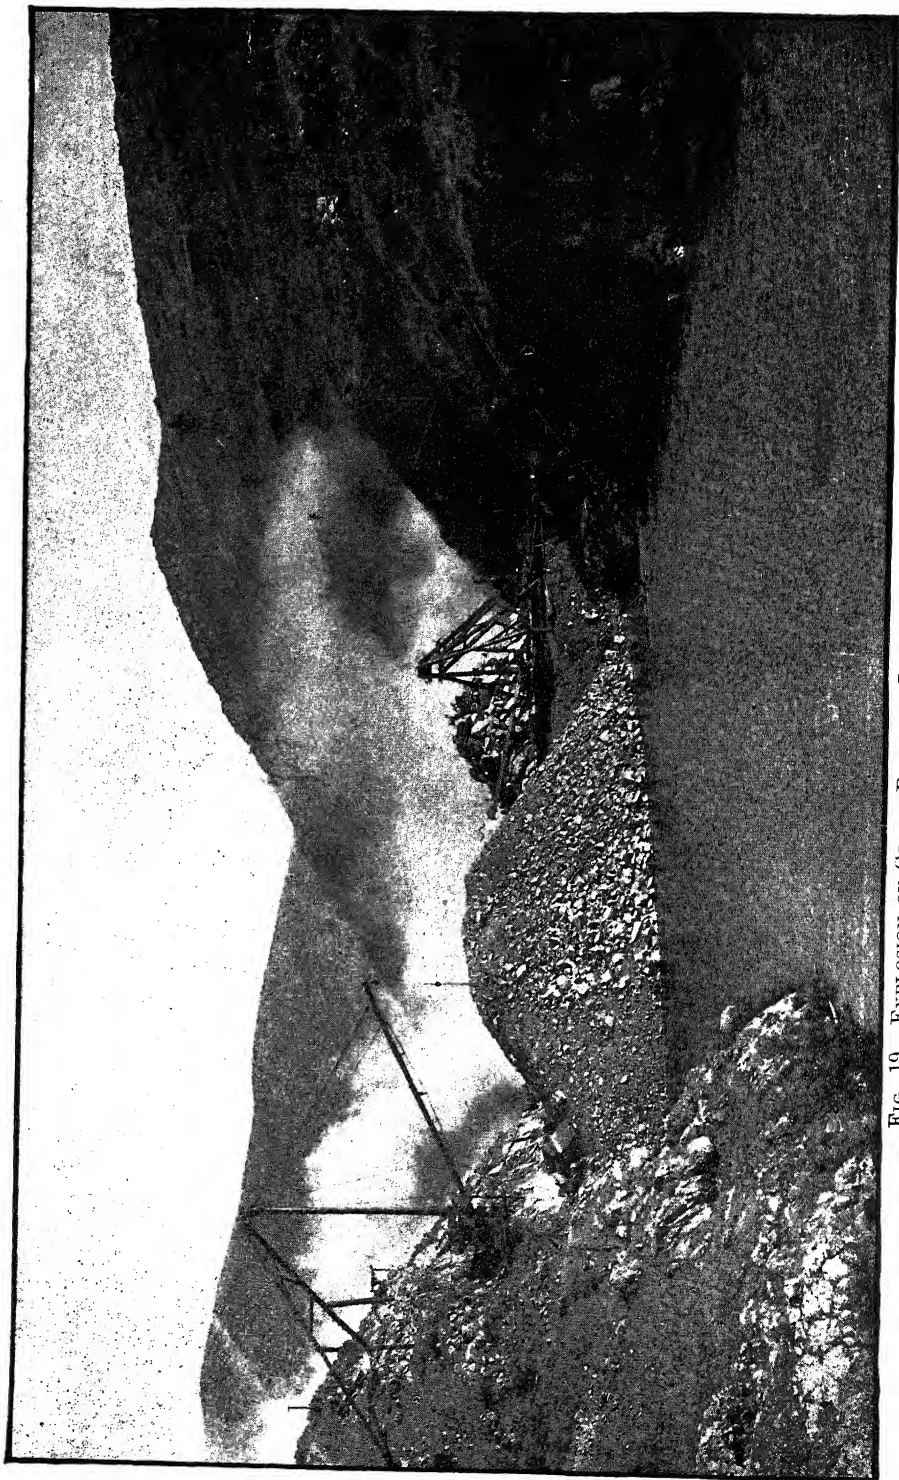
FIG. 19.—EXPLOSION OF GREAT BLAST AT LOWER OTAY ROCK FILL DAM.

*Quarry.*—All or the greater portion of the rock used was loosened in the quarry by very heavy blasts, the first of which was made by driving a tunnel 50 feet into the face of the cliff with lateral drifts, 18 and 28 feet long respectively. In the shorter drift, 4000 pounds of Judson powder (containing 5% nitro-glycerine) under a vertical depth of 70 feet, and in the larger, 8000 pounds under a depth of 85 feet, were exploded simultaneously, which resulted in loosening and throwing out about 50,000 to 75,000 cubic yards. A view of this blast taken at the moment of explosion is shown in Fig. 19. The second large blast was prepared by sinking a shaft 115 feet deep, 85 feet back from the nearly vertical face left by the first blast. At a depth of 50 feet two drifts were run laterally a distance of 25 feet each, and at the bottom of the shaft two more drifts, 30 and 35 feet long respectively, were extended into the rock toward the face and in the opposite direction, and the four holes thus prepared were loaded with 30,000 pounds of powder, of which the greater portion was located in the bottom drifts. This blast did greater execution than the first, and supplied sufficient rock to complete the dam. Minor blasting of the ordinary class was necessary throughout the work to break up the larger masses to sizes that could be handled by the cableway. The quarry being near the lower toe of the dam, the first large blast filled in the toe with large boulders, some of which weighed upwards of 50 tons, and a subsequent freshet, pouring over and through these rocks, scoured out the sand beneath them so as to settle them well to bed-rock, which was a fortunate occurrence.

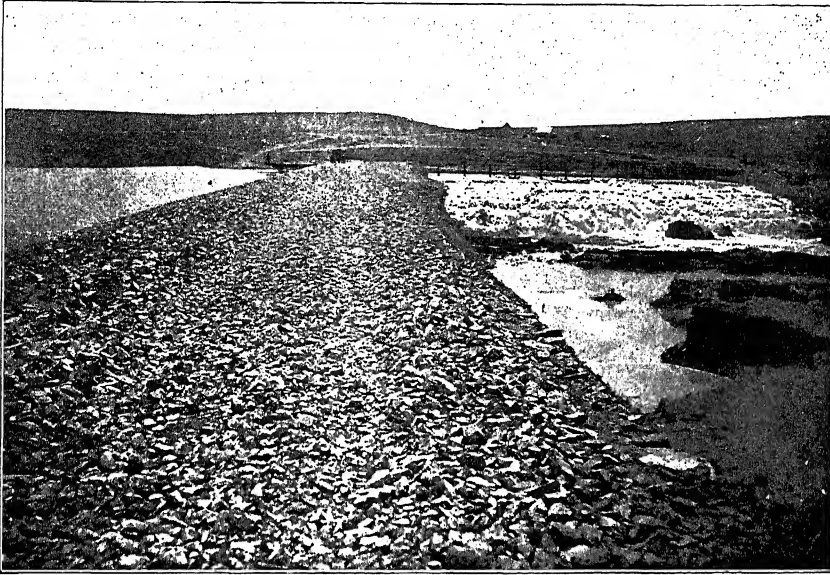
FIG. 34.—LAKE AVALON DAM, PECOS RIVER, NEW MEXICO. SHOWING THE CREST OF COMPLETED DAM AND SPILLWAY DISCHARGING.

fill before the addition of the earth facing is illustrated by Fig. 33, a view taken during construction. Fig. 34 is a view of the finished dam, taken in 1892. The grade of the main canal leading out from the dam on the east side of the valley is 10 feet above the base of the dam, and is excavated in limestone to a maximum depth of 38 feet. Fig. 35 is a view of the main canal and headgates, taken from the lower side.

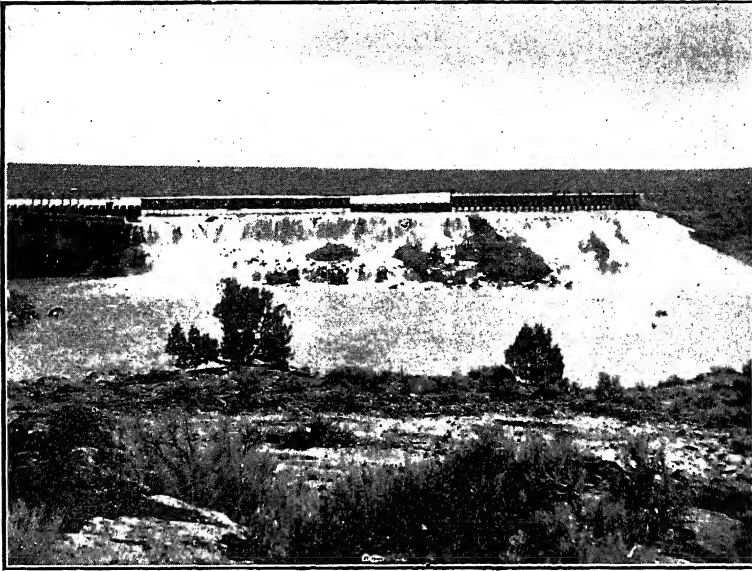
FIG. 47.—MILNER DAM, SNAKE RIVER, IDAHO. DISCHARGE THROUGH THE GREAT BATTERY OF 99 WASTE-GATES FORMING "IRRIGATION FALLS," 40 FEET HIGH.

Figs. 47, 48, 49, 50, 51, and 52 illustrate the construction of these notable dams, and Fig. 53 shows the type of head-gates successfully

**The Milner Dam, Idaho.**—The photograph shown in Fig. 355 gives a more comprehensive picture of the three combination dams described on page 60 than any of the other illustrations accompanying the article (see Figs. 47 to 53), and will therefore add to the interest in these important and successful dams.

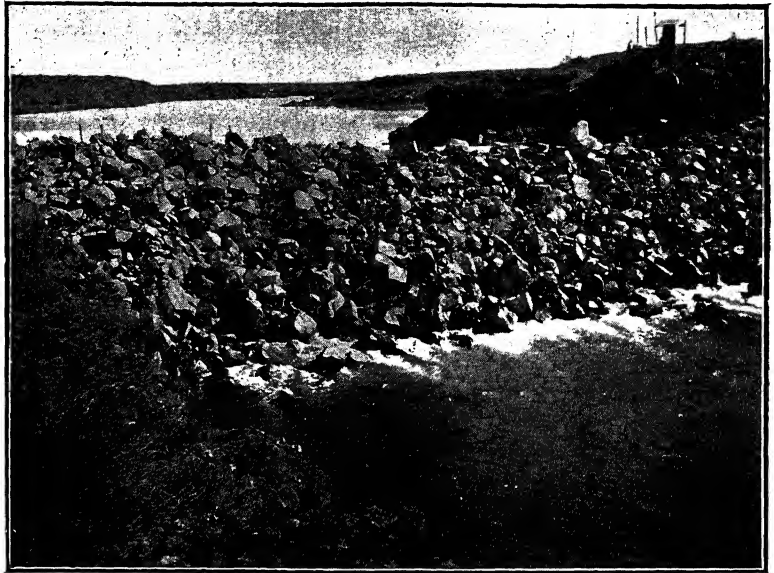
FIG. 49.—MILNER DAM, SNAKE RIVER, IDAHO. NORTH CHANNEL DAM BEFORE COMPLETION OF SHEET PILING. ABOUT 500 SECOND-FOOT IS PASSING THROUGH ROCK-FILL, UNDER HEAD OF 13 FEET.

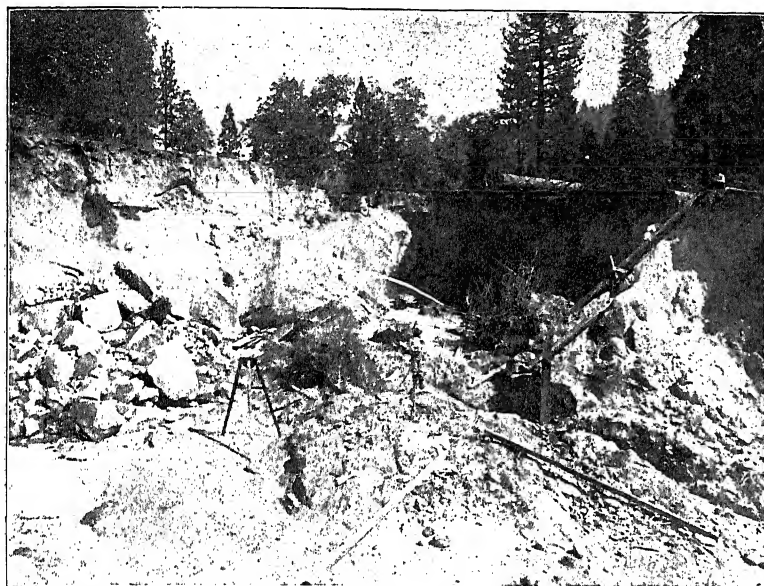
FIG. 81.—CRANE VALLEY HYDRAULIC-FILL DAM. SHOWING METHOD OF LOOSENING THE MATERIALS SLUICED INTO THE DAM.

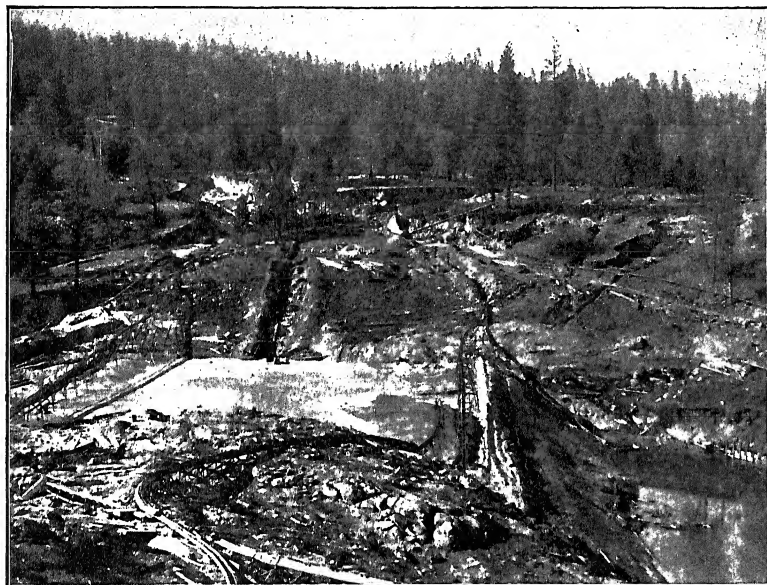
FIG. 82.—BORROW-PITS FROM WHICH MATERIAL WAS SLUICED TO THE CRANE VALLEY DAM IN BACKGROUND.

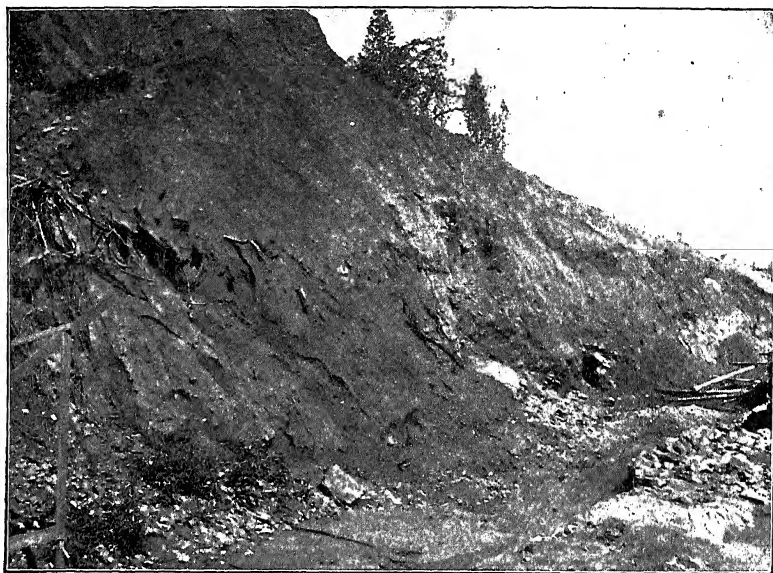
FIG. 85.—NEAR VIEW OF RIGHT SIDE OF BREAK IN EMBANKMENT OF LAKE FRANCES DAM SHOWING ROOTS EXPOSED BY THE BREAK.

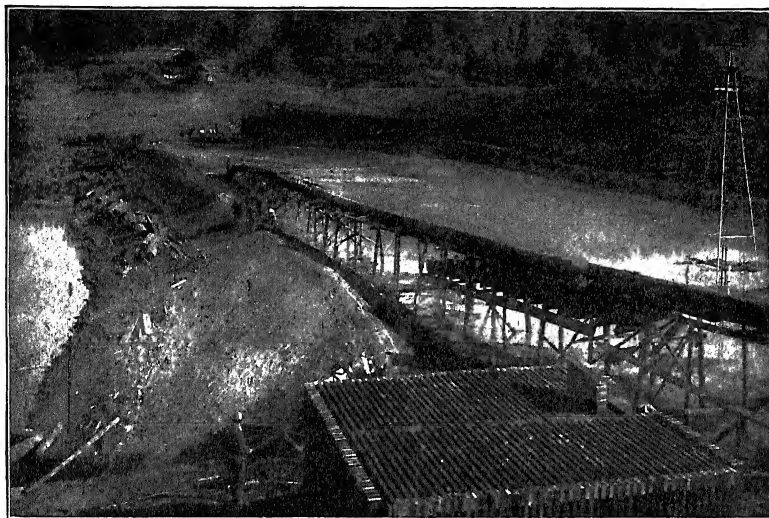
FIG. 86.—TOE LEVEE OF NORTH FACE, LAKE FRANCES DAM, AND INLET CRIB AT HEAD OF FIVE-FOOT OUTLET CULVERT.

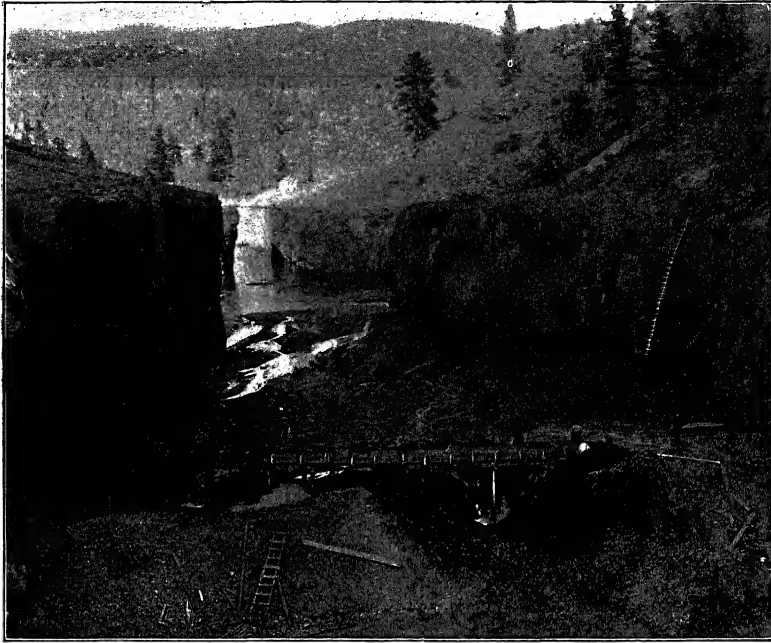
FIG 104.—TERRACE DAM, COLORADO, LOOKING UP-STREAM. ILLUSTRATING GRADATION OF MATERIAL TOWARD THE CENTER OF THE DAM FROM THE POINT OF DEPOSIT AT THE SLOPES.

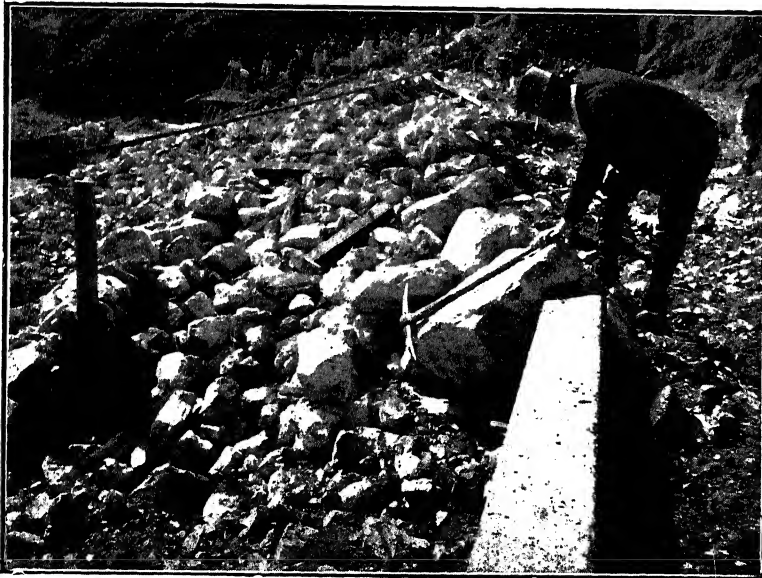
FIG. 119.—ILLUSTRATING THE SIZE OF STONE DELIVERED BY FLUME TO THE NECAXA DAM. THE LARGEST ONE MEASURED CONTAINED 18 CUBIC FEET.

of 60% to 70% mingled with stones of all sizes. The photographs, Figs. 118, 119, 120, 121, and 124 show the nature of the materials delivered to each and the manner of delivery.

A striking feature of this work, as illustrated by the photographs, Figs. 118 and 119, taken by the author in January, 1908, is the large size of rocks which have been transported through the flumes and deposited on the dam. Many of these contain upwards of 15 cubic feet and weigh over 1 ton. In this respect the magnitude of the operation exceeds any hydraulic sluicing ever before attempted. The down-stream slope is being covered with 2 feet of masonry laid in Portland cement, using

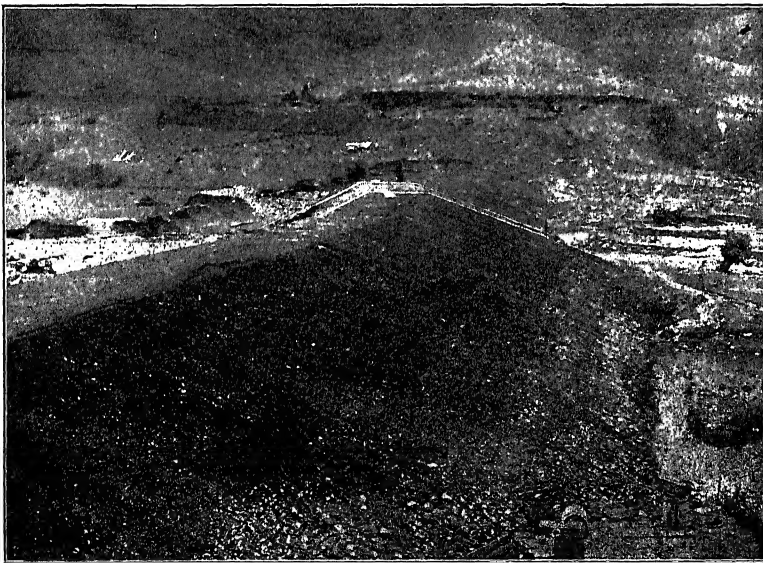
FIG. 133.—DAM No. 1, AT ACATLAN, TENANGO RIVER, COMPLETED JULY, 1906. THE MATERIALS FOR THE DAM WERE GROUND-SLUICED FROM THE BORROW-PITS IN THE BACKGROUND.

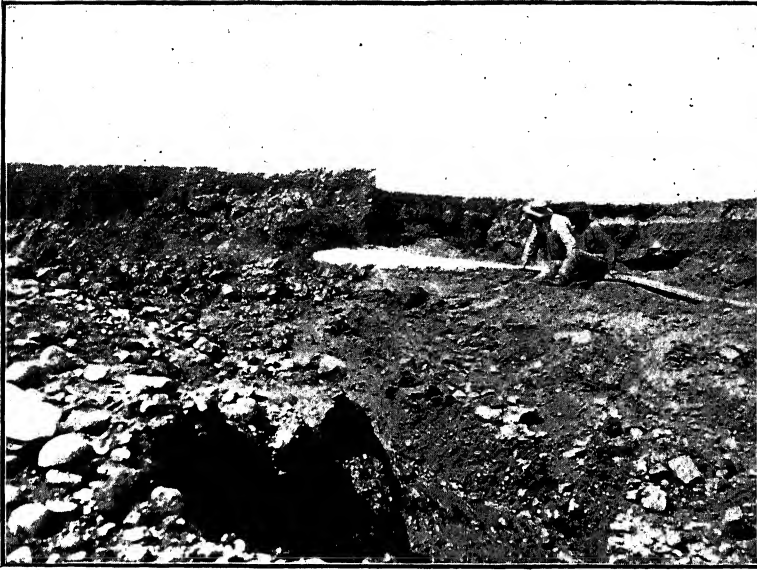
FIG. 134.—YORBA DAM, CALIFORNIA. HYDRAULICKING AN EARTH BANK WITH WATER PUMPED THROUGH 1-INCH NOZZLE UNDER 25 POUNDS PRESSURE.

Fig. 134 shows the operation of hydraulic sluicing, and Fig. 135 illustrates the method of delivery of earth upon the dam. The surplus water was drained from the pond through stand-pipes built up in successive layers and connecting with the main outlet-pipe through which the water was fed into the reservoir. The entire cost of the dam was about \$38,000.

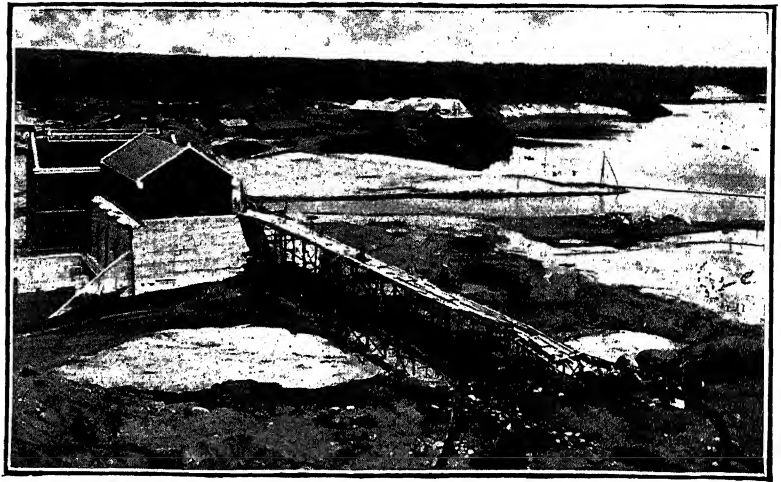
FIG. 137.—CROTON HYDRAULIC-FILL DAM, MICHIGAN, DURING CONSTRUCTION.

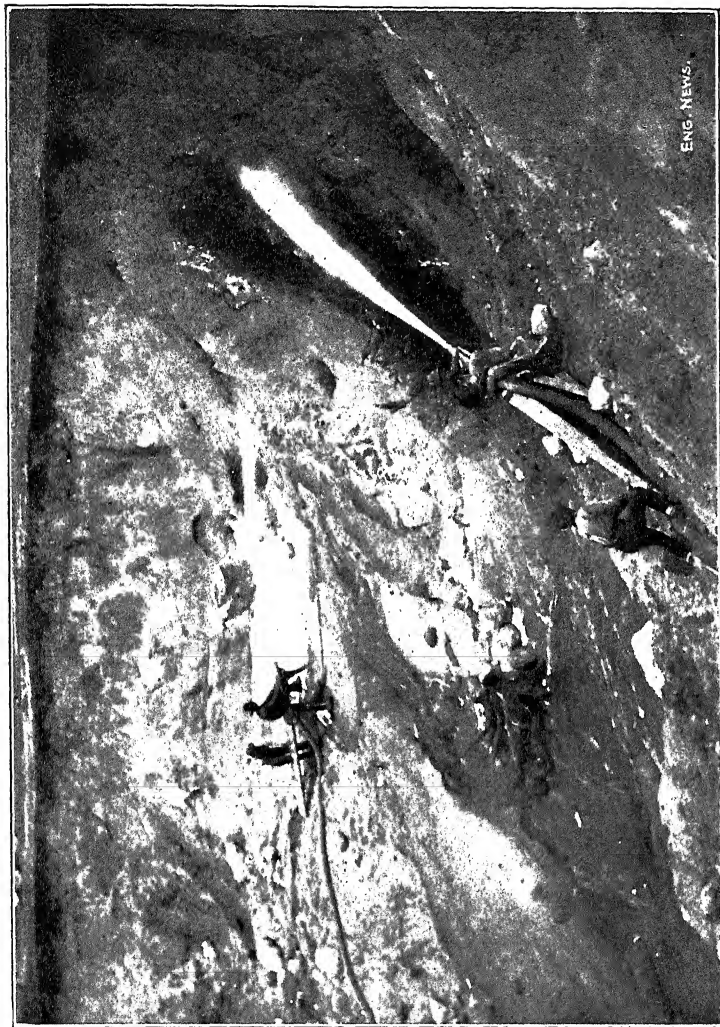
FIG. 139.—HYDRAULIC SLUICING ON THE CROTON DAM, SHOWING THE IMPROVISED NOZZLE CONTROL,  
OR HYDRAULIC MONITOR.

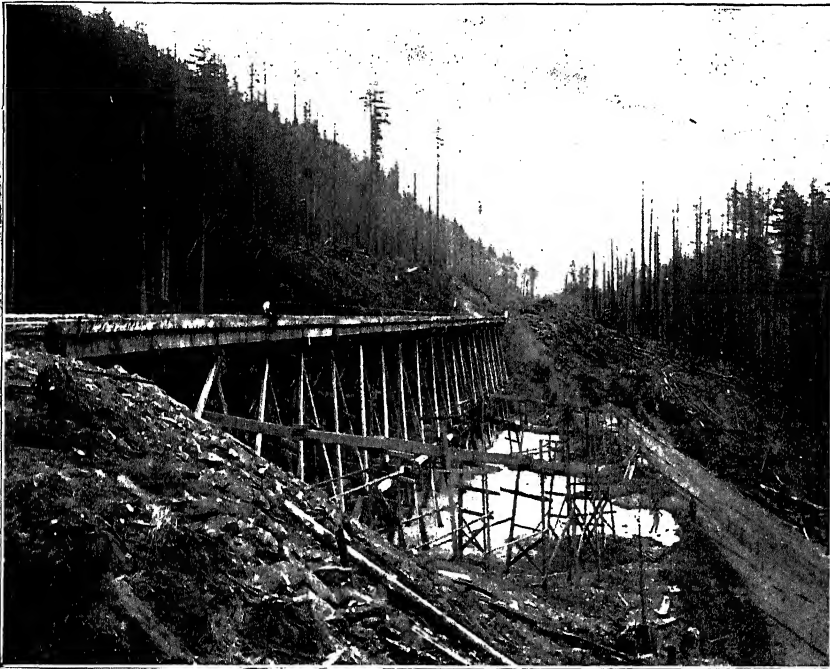
FIG. 143.—NORTHERN PACIFIC RAILWAY. BRIDGE 190.

By courtesy of E. H. McHenry, Chief Engineer, and Charles S. Bihler, Division Engineer, Northern Pacific Railway, the writer has been furnished with the interesting photographs of the work (Figs. 143, 144, 145, and 146), which illustrate the process of hydraulic filling very clearly in all its phases, and demonstrate with what precision embankments can thus be

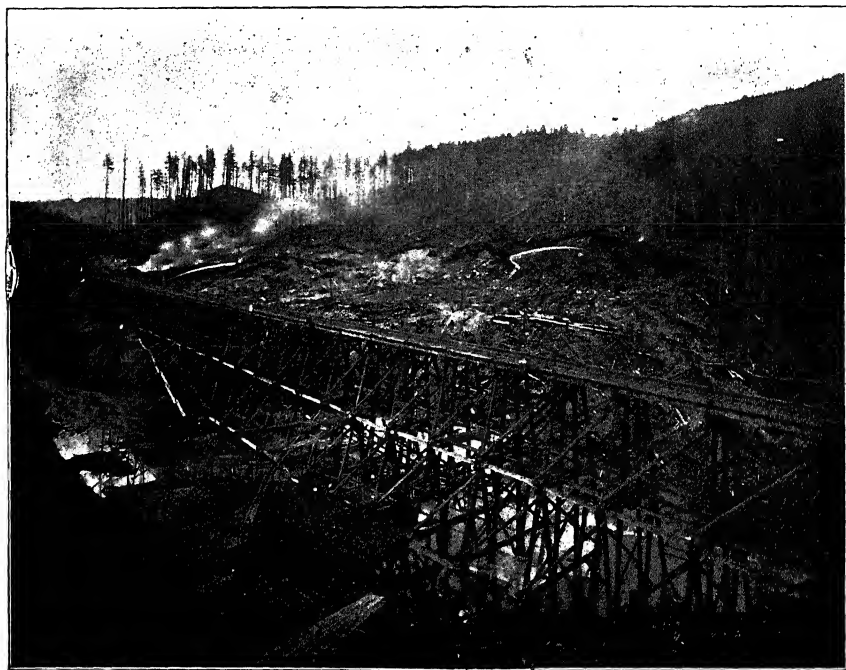
FIG. 144.—NORTHERN PACIFIC RAILWAY. BRIDGE 189, CASCADE MOUNTAINS.

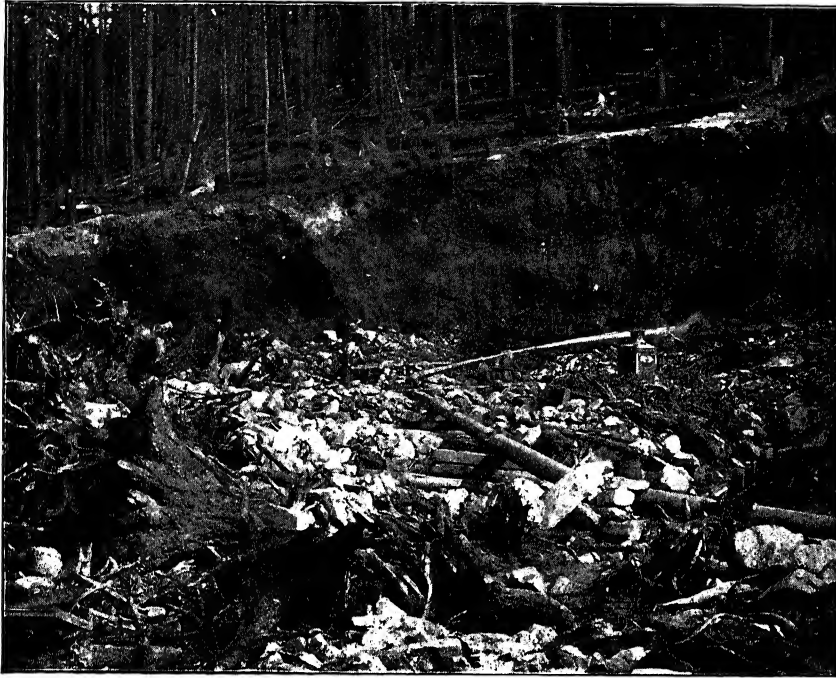
FIG. 145.—NORTHERN PACIFIC RAILWAY, HYDRAULIC-FILL CONSTRUCTION. VIEW IN PIT SHOWING HYDRAULIC GIANT IN ACTION.

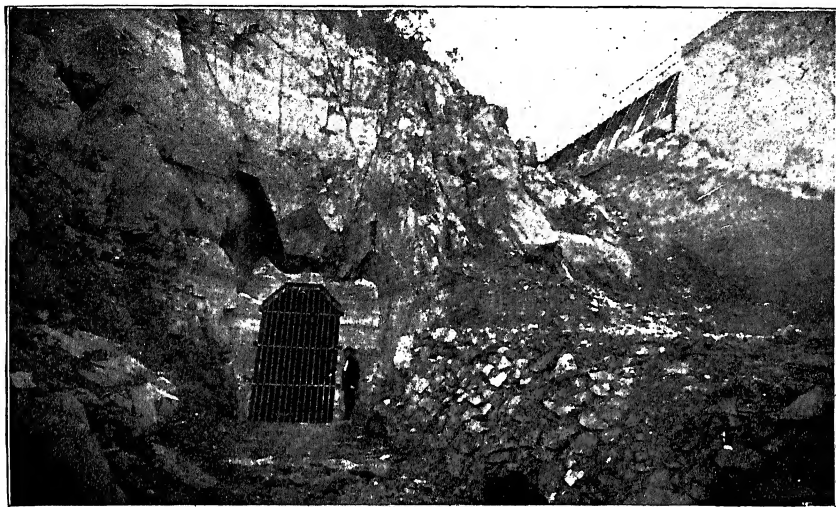
FIG. 163.—SWEETWATER DAM, SHOWING HEAD OF OUTLET TUNNEL AND SPILLWAY.

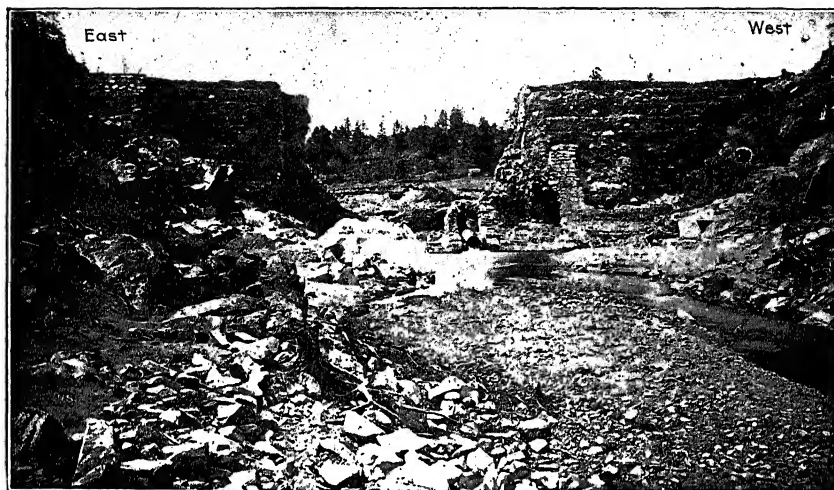
FIG. 209.—LYNX CREEK DAM, ARIZONA, AFTER RUPTURE BY FLOOD. VIEW FROM BELOW.

floods draining the tributary watershed of 30 square miles of territory, from 5500 to 7500 feet in elevation, had the masonry been of reasonably good quality. The failure, therefore, was clearly due to poor workmanship and unsuitable materials. The dam was 150 feet long on crest, and was built with a central angle of about  $165^{\circ}$  opposed to the direction of the current, the up-stream face being vertical. The wall consisted of a thin facing of hand-laid masonry, not over one foot thick, the core being filled with a weak concrete of fine gravel, stone, spawls, and sand. The section of the dam as constructed is clearly seen from the photograph (Fig. 210). Considerable lime was used with the cement, which was of poor quality, and the concrete, though ten years old, possesses so little cohesion that it may be crumbled with a light touch. The cement used averaged but 1 barrel to 6 cubic yards of masonry. The failure of the dam, under all the circumstances, might have been anticipated. It is referred to here merely as an example to illustrate the natural consequences that must follow any carelessness or lack of attention to proper selection of materials and skill of construction in masonry or concrete dams that must withstand the erosive action of floods as well as normal water-pressure.

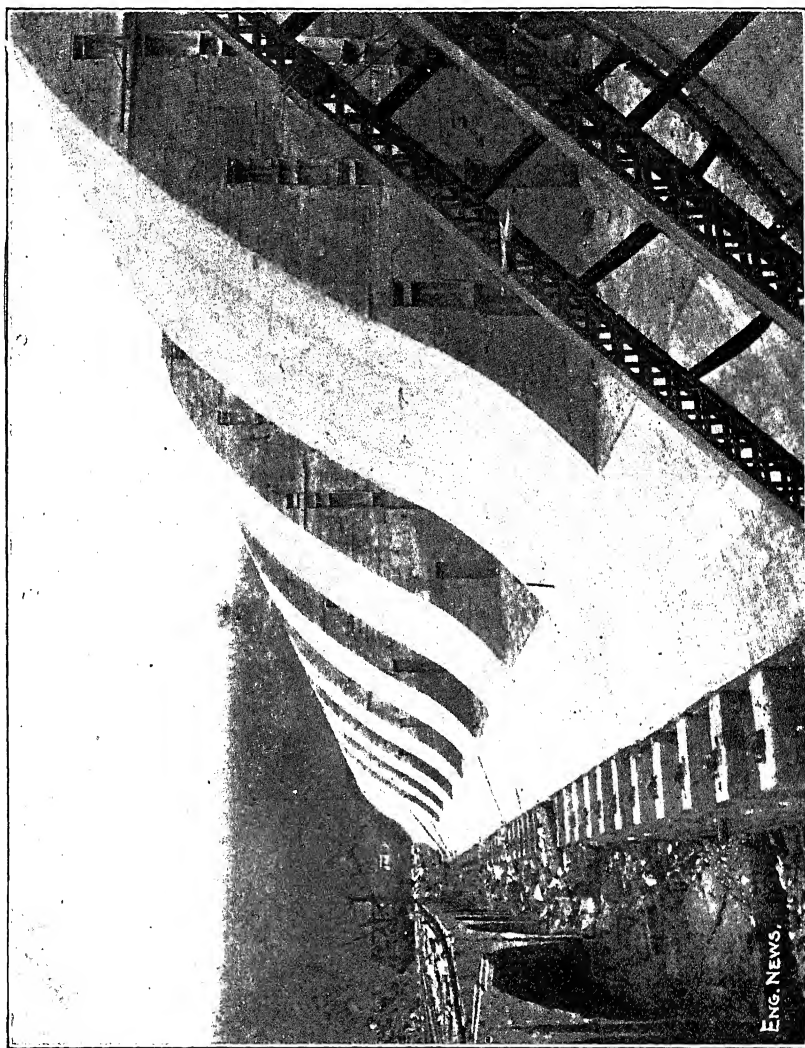
FIG. 241.—McCALLS FERRY DAM, PENNSYLVANIA.

miles west of Philadelphia, by the erection of a masonry dam, 55 feet maximum height, 2350 feet in length, with a base width of 65 feet. The dam is of ogee form, and is to be used as an overflow for its entire length. The dam when completed will contain 330,000 cubic yards of concrete, including that in the power house and the construction bridge.

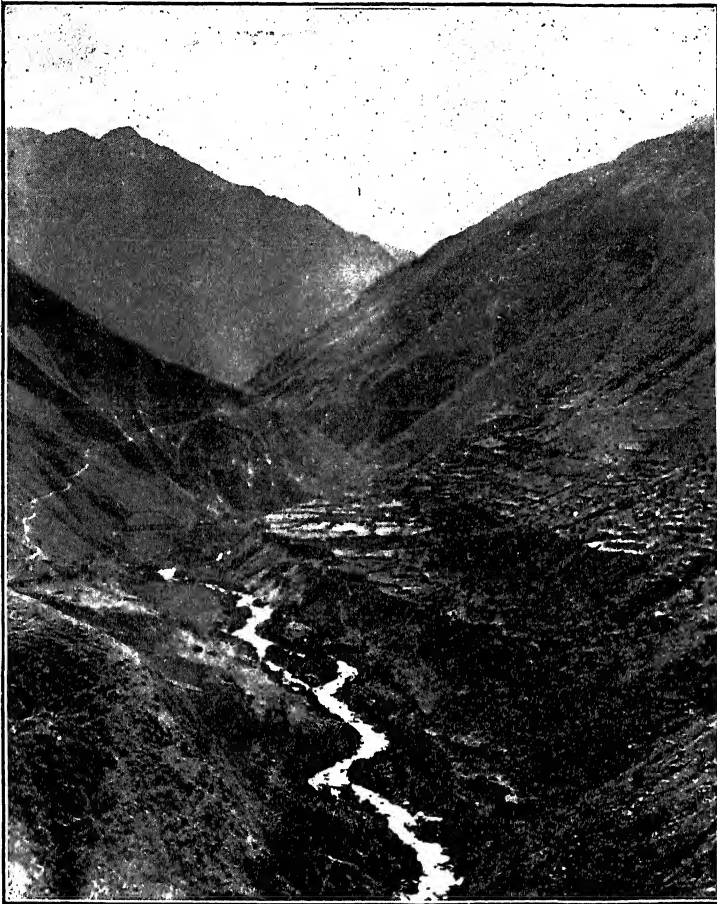
FIG. 282.—RESERVOIR SITE ABOVE PROPOSED AUTISHA DAM, PERU.

of unprecedented height. Fig. 281 is a view of this phenomenal canyon, and Fig. 282 is a photograph of the reservoir basin above the dam. The opportunity for water power development is also remarkable on these rivers, which fall so very precipitously toward the west. One branch of the Rimac river falls 7300 feet in a distance of 35 miles, with a minimum flow of 250 sec.-feet, capable of developing 200,000 H. P. This is a fair illustration of nearly all the rivers of Peru flowing into the Pacific Ocean.

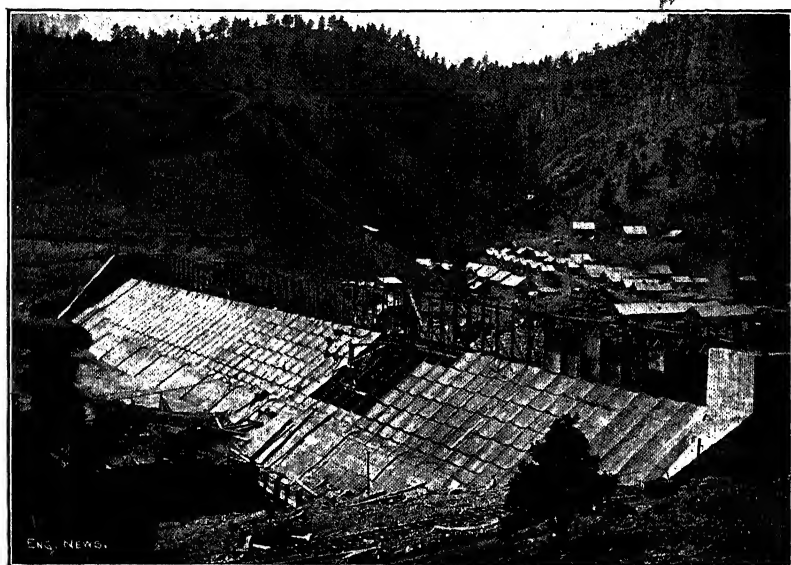
FIG. 303.—HAUSER LAKE DAM, MONTANA, NEARING COMPLETION.

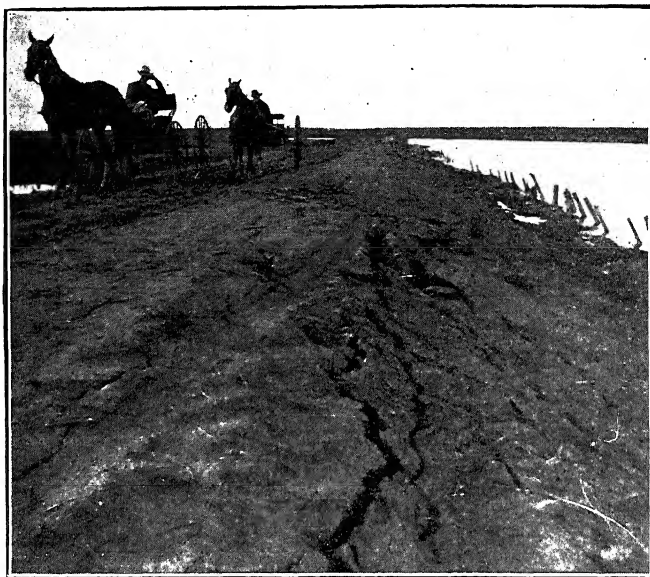
The great cracks in the dam are the conspicuous feature of the picture, and are evidence of the lack of proper care and supervision in important works of this character. The dam contains about 150,000 cubic yards of earth, and forms a reservoir of 10,600 acre-feet capacity, sufficient to create great havoc in the country below it if it were suddenly released. The reservoir is filled by a ditch from the North Poudre river.

FIG. 333.—DOUGLAS LAKE DAM, COLORADO, SHOWING DANGEROUS SETTLEMENT CRACKS, DUE TO IMPROPER METHOD OF CONSTRUCTION.

**The Douglas Lake Reservoir, Colorado.**—An earth dam across a natural depression on Dry Creek, five miles northwest of Fort Collins, Col., was built in 1902, an illustration of which is shown in Fig. 333.

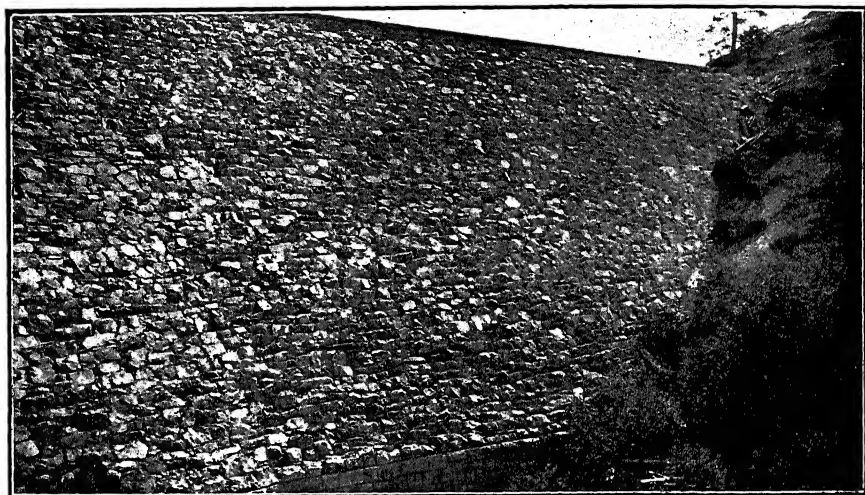
FIG. 338.—DOWN-STREAM FACE OF BOWMAN LAKE DAM, CALIFORNIA, ILLUSTRATING THE QUALITY OF THE DRY MASONRY.

**The Bowman Rock-fill Dam.**—Renewed interest is being taken in the old rock-fill dams of the Sierra Nevada Mountains, in Northern California, built originally to store water for hydraulic mining, because they are becoming valuable for the double uses of generating power and affording domestic and irrigation supply to the valley below. The Bowman dam, described on page 65, and outlined by cross-sections, Fig. 44, is more clearly illustrated in its situation and construction by Figs. 336, 337, 338, 339, and 340.

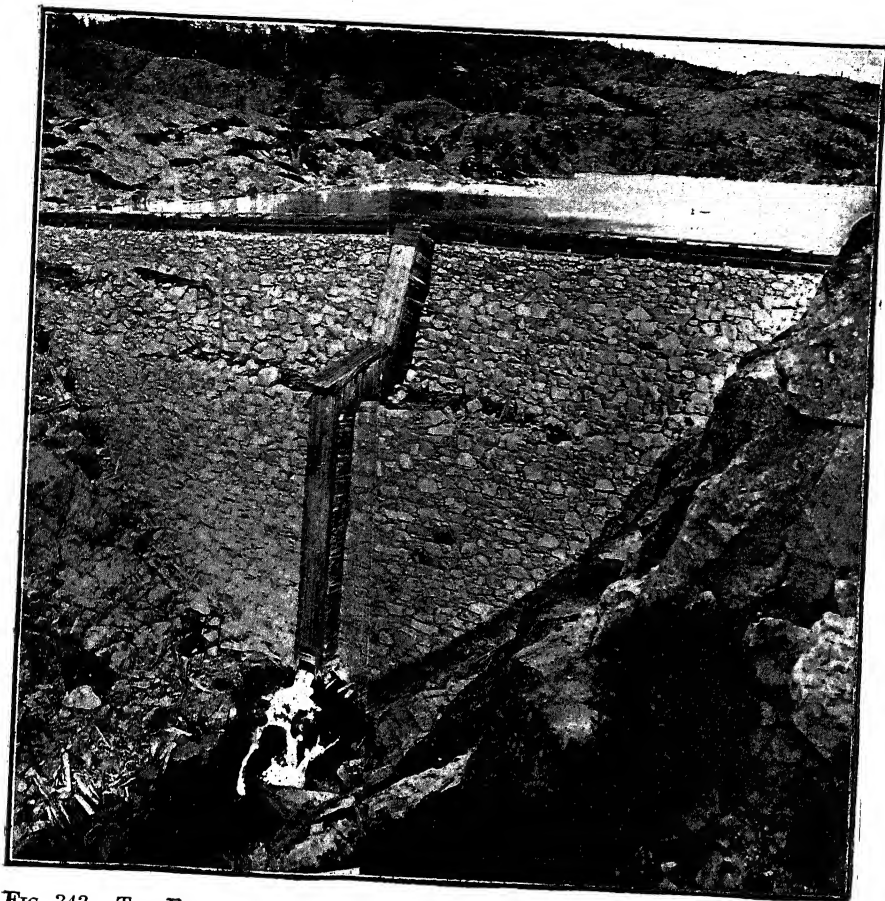
The water is drawn out through an arched sluiceway under the center of the dam, the gates of which are only accessible in winter through the box-like structure, or manway, shown in the photographs, which protects the ladder resting on the face of the dam from the deep snow. The gates are situated near the water face of the dam, at the end of the arched sluiceway.

FIG. 343.—THE EUREKA LAKE ROCK-FILL DAM, CALIFORNIA, SHOWING COVERED MAN-  
WAY TO REACH GATES FROM CREST IN WINTER.

The offset shown in the photographs (Figs. 343 and 344) was the result of an enforced economy during construction when money became scarce. The dam is built entirely of rock (without timber cribs), rather loosely placed, and with the larger stones in the down-stream face laid up in the form of a dry wall. The up-stream face is made water-tight with two layers of a 3-inch pine planking, laid with broken joints, spiked to inclined posts sunk flush with the stone work, which is also laid up with care as a dry wall, to receive the pressure of the water transmitted through the planks. On the crest is a timber structure about 6 feet high, made by extending the inclined posts and timber facing above the stonework.

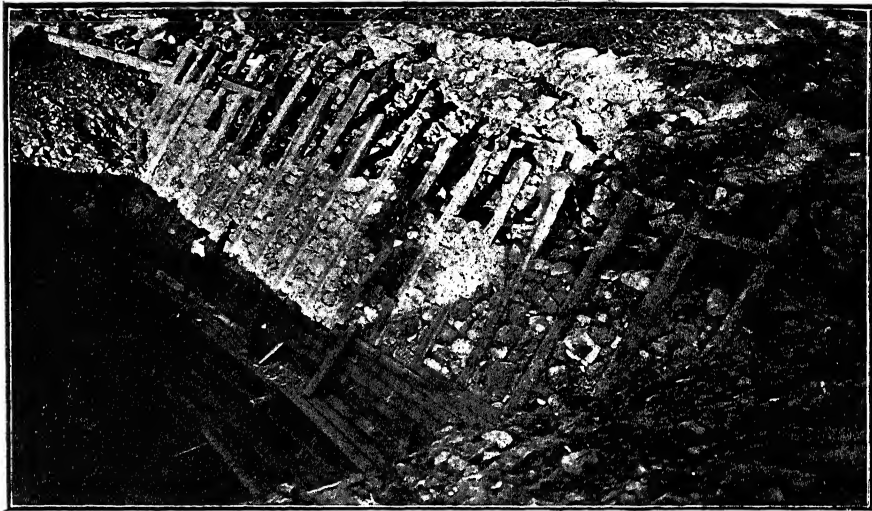
Inclined posts, placed at an angle of  $45^{\circ}$ , are first set up and held in position by struts that are subsequently removed. These posts are long enough to reach from bed-rock to the crest of the dam. The rock-fill is carefully laid by hand between the posts, forming a face flush with the exterior face of the posts. They are spaced 4 feet apart, center to center. At intervals of 6 feet, from bottom to top, an iron rod,  $\frac{3}{4}$  of an inch in diameter, passes through each of the posts to an anchorage back in the rock-fill. This anchorage is made by winding the rods around the largest stones that are selected for that purpose. These posts are of varying size, but the smallest are 9 inches across at top.

The plank face is made with but one layer of well-seasoned  $3'' \times 8''$  pine plank, laid horizontally, and driven tightly together. The bottom

FIG. 345.—THE WEAVER LAKE DAM, CALIFORNIA, SHOWING RECENT CONSTRUCTION.

edge of each plank is cut with a caulking bevel of one-half inch in the thickness of 3 inches, but no caulking is done by hand, reliance being placed upon the sediment and floating organic matter in the water to make the joints tight. The planks are held by two 6-inch spikes at each post.

**The Weaver Lake Dam.**—A new dam has recently been constructed at Weaver lake, within a mile of Bowman dam, which is typical of the class of rock-fill wood-faced dams. The method of construction is well shown by the photograph, Fig. 345.

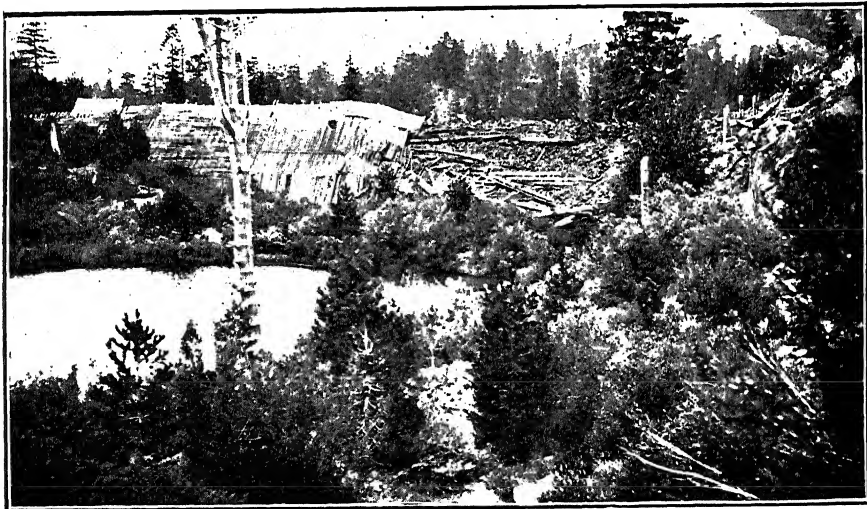
FIG. 347.—GENERAL VIEW OF THE TIMBER SKIN ON UP-STREAM SIDE OF THE ENGLISH LAKE DAM. NOW IN RUIN.

**The English Dam.**—On pp. 63–64 the high rock-fill structure known as the English Dam is described, with an account of the bursting and destruction of the main dam, the central one of three which formed the reservoir. Figs. 346, 347, and 348 illustrate the style of construction and present condition of the principal one of the two remaining dams.

The existing dams both have a crest extension of wood, 6 feet high, of similar construction. (See Figs. 346 and 347.) This is also well illustrated by Fig. 348, showing the dry wall laid up on the down-stream face.

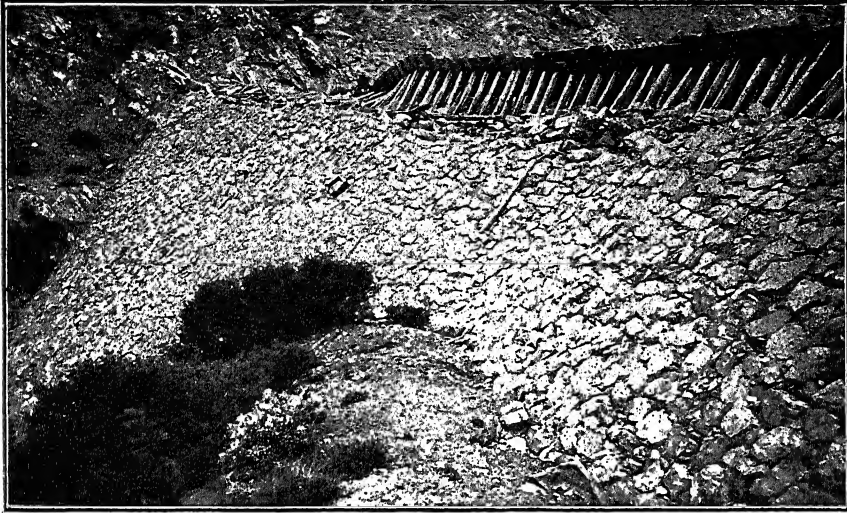
FIG. 348.—THE DOWN-STREAM FACING OF THE ENGLISH LAKE DAM, CONSISTING OF A HAND-LAID DRY WALL IS WELL ILLUSTRATED BY THIS PHOTOGRAPH.

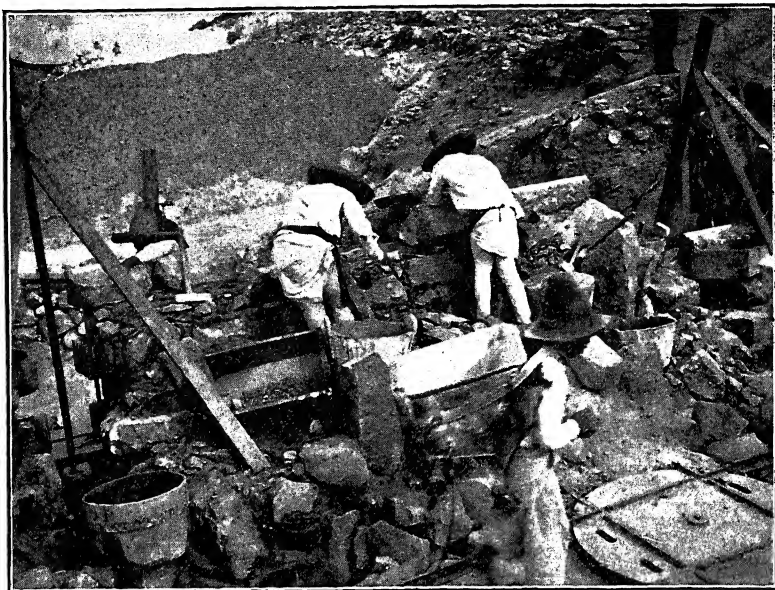
FIG. 374.—MASONS AT WORK ON THE SAN JOSÉ DAM, MEXICO.

**The San José Dam, San Luis Potosi, Mexico.**—In 1901, at the time the photographs shown in Figs. 371, 372, 373, 374, and 375 were taken, a private company was engaged in building a high masonry dam for the storage of water to supply the city of San Luis Potosi and to irrigate land in its vicinity. The city is a stockholder in this corporation. The dam as subsequently completed has an extreme length on the crest of 592 feet, and a maximum height of 151 feet from the lowest foundation to the crest, or 110 feet from the stream-bed to the top. Its thickness at the base is 128 feet, and at the crest about 15 feet.

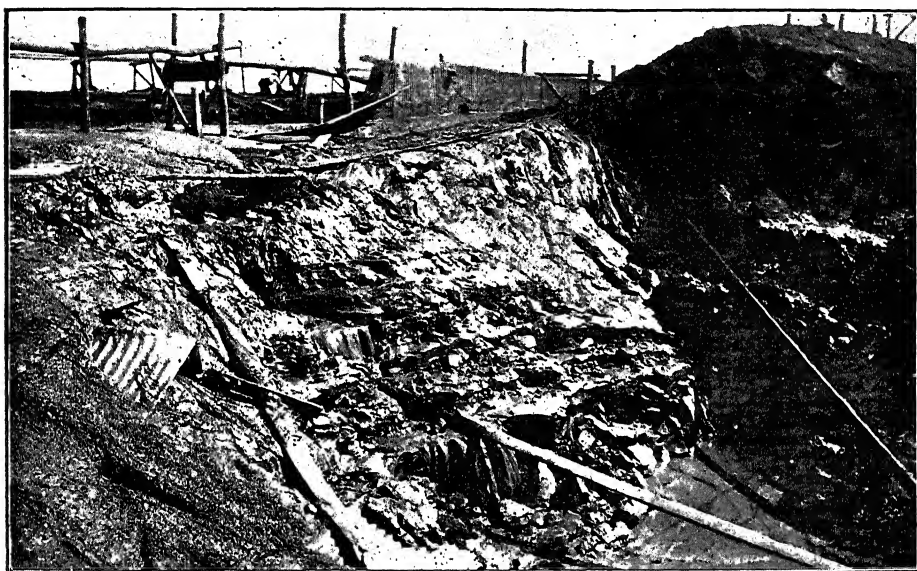
FIG. 377.—ILLUSTRATING THE COMPACT CHARACTER OF THE CLAY CORE OF THE SANTO AMARO DAM, ACCIDENTALLY EXPOSED TO VIEW BY A BREAK FROM THE POND ON TOP OF THE DAM.

The remarkable picture shown in Fig. 377 is the best possible demonstration of the effect of hydraulic sluicing in the segregation of pure clay from a mass of coarser materials, and its deposit in a condition of stable solidity within a short time. It is a picture of the clay core of the Santo Amaro dam accidentally exposed to view by a break in one of the lateral levees, the effect of which was to empty the pond on the dam and wash

away the levee and its supporting base of coarser material for a distance of about 50 feet. The break, which occurred in the up-stream slope, caused the loss of 400 cubic yards of material, but the demonstration of the stability of the clay core, none of which had been deposited three months, and some of it but a few days, was worth far more than the loss. The clay as exposed was left standing almost vertically, and it had successfully withstood the wash of water pouring over it from the emptying of a pond several hundred feet long, 50 to 60 feet wide, and 2 to 4 feet deep, with comparatively slight erosion. The break was caused by the saturation of the levee, built of material brought in by cars, which, not being sluiced and assorted, the finer particles from the

The conditions of solidity and maturity in the clay core shown in this case is a most reassuring endorsement of the superiority of the hydraulic sluicing method of dam construction.
